ORNL/TM-7165

Effects of Alternate Fuels
Report No. 8: Analysis of
Degradation of Magnesia-Based
Refractory Bricks from a Residual
Oil-Fired Rotary Cement Kiln

J. I. Federer
V. J. Tennery

Date Published: May 1980

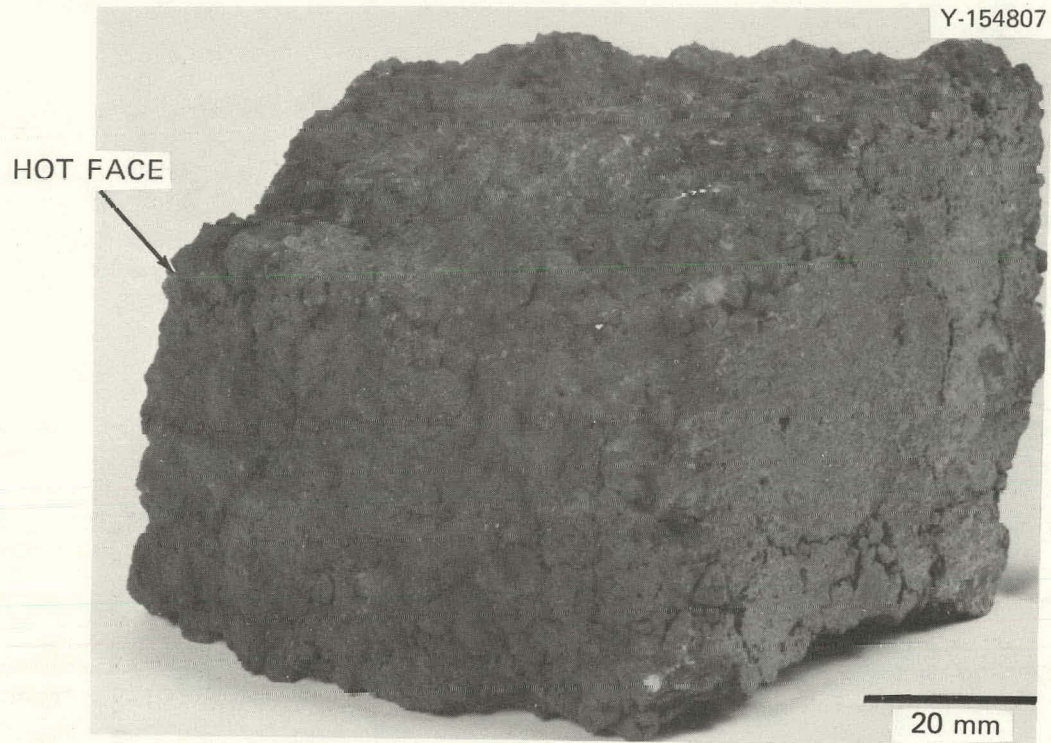
The sections of two bricks received for analysis are shown in Figs. 2 and 3. The hot face on each brick was irregularly shaped rather than flat, as in the case of the original brick shown in Fig. 1. A light-green adherent coating was present on the hot face of each brick. Figures 4 and 5 show how the bricks were sectioned with a diamond abrasive wheel to obtain samples for analyses. The disposition of these samples is shown in Table I.

Fig. 2. Degraded small-brick specimen. Note the rough appearance of the hot face.

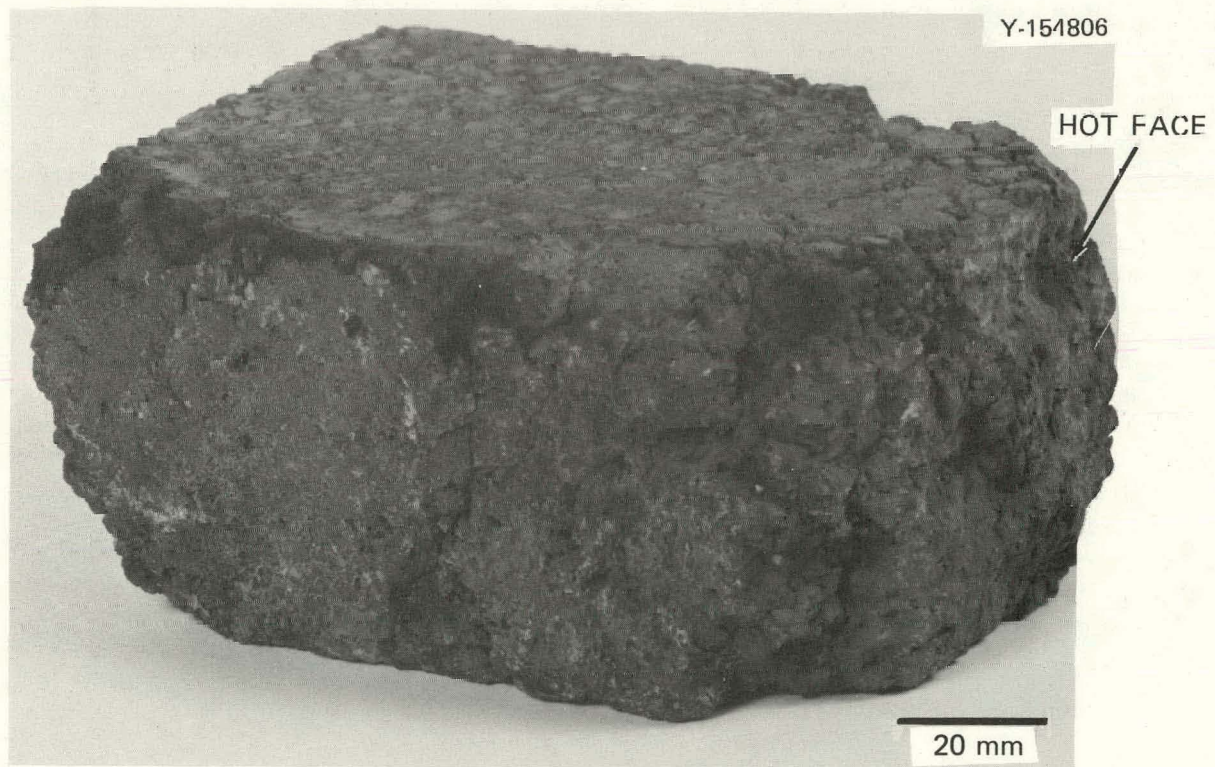
Fig. 3. Degraded large-brick specimen. Note the rough appearance of the hot face.

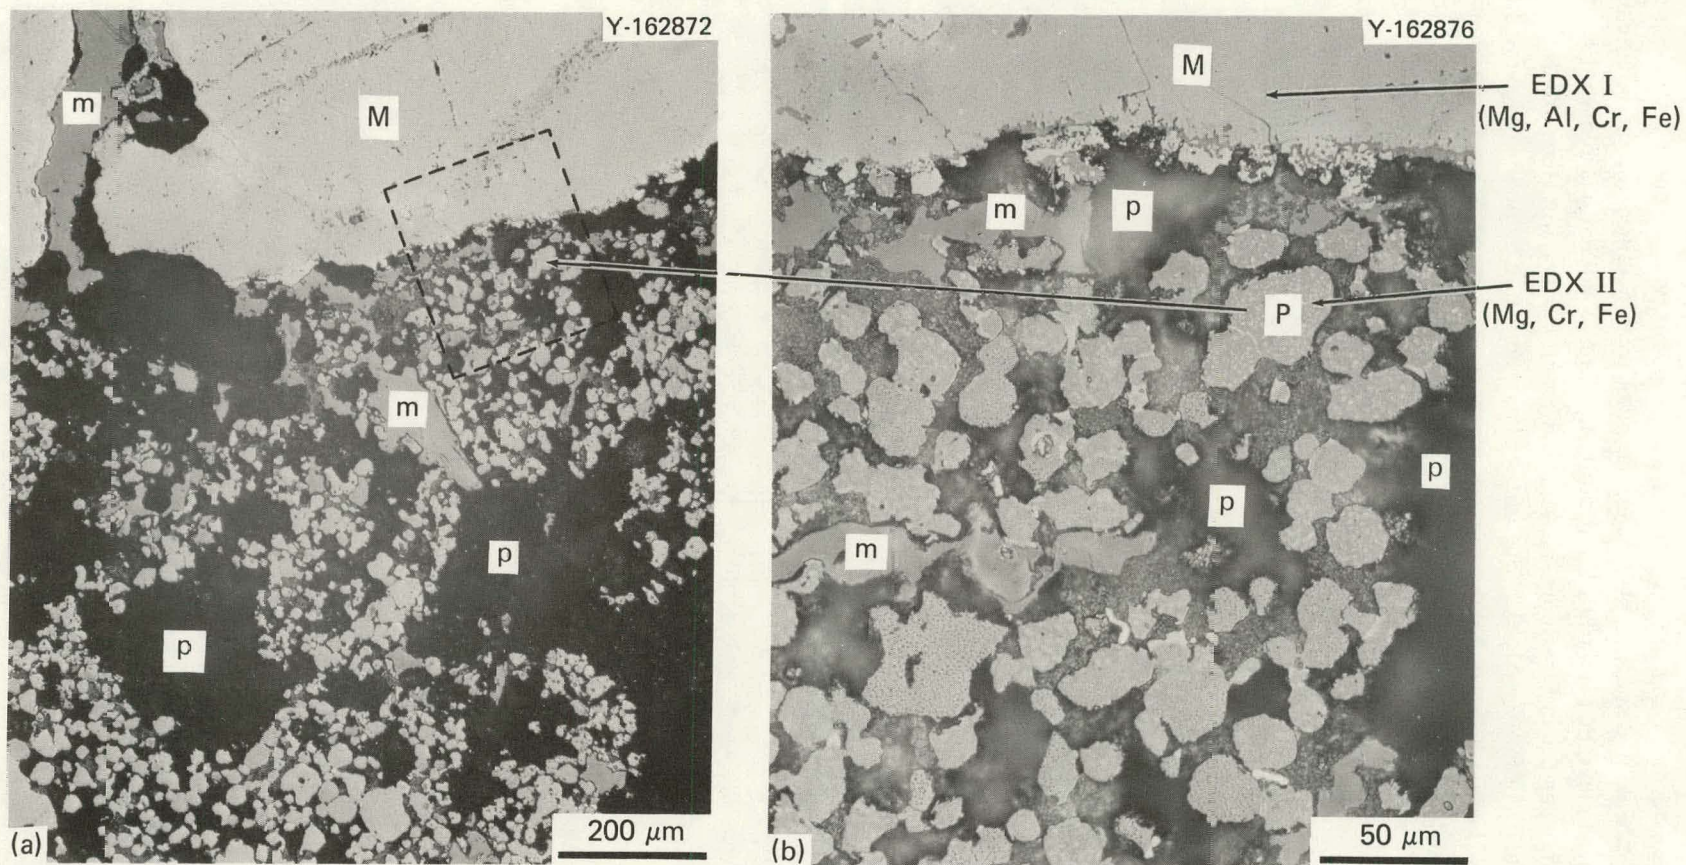
The microstructure of the large brick in an area of the cold face is shown in Fig. 6. Figure 6a shows that the material consists of large dense particles of magnesiochromite in a matrix of smaller particles.

Fig. 6. Microstructure of cold face of large brick (sample 10B). (a) Showing porosity in the matrix of small grains, 100X. (b) Showing that small grains are loosely joined, 400X. *M*: magnesiochromite, $(\text{Mg,Fe})(\text{Cr,Al})_2\text{O}_4$; *P*: periclase, MgO ; *m*: mounting material; *p*: porosity.

Much porosity is evident among the smaller particles (Fig. 6a), which appear to be loosely joined together (Fig. 6b). Energy-dispersive x-ray analysis plots were obtained for the microconstituents shown in Fig. 6, wherein EDX I and EDX II indicate typical areas analyzed. The plot for EDX I in Fig. 7 shows that the large particle in Fig. 6 contains Mg, Al, Cr, and Fe; therefore, the particle most likely is magnesiochromite $[(\text{Mg,Fe})(\text{Cr,Al})_2\text{O}_4]$, one of the phases shown to be present by x-ray diffraction. The plot for EDX II in Fig. 8 shows that the smaller, loosely joined particles in Fig. 6 contain magnesium as the major element, with smaller amounts of Cr, Mn, and Fe. The particles probably consist of periclase (MgO), with Cr, Mn, and Fe in solid solution, and magnesioferrite ($\text{MgO} \cdot \text{Fe}_2\text{O}_3$). Essentially the same results were obtained for any of the small particles shown in Fig. 6, even though they differ in appearance, some containing small uniformly dispersed white areas and others having small uniformly dispersed black areas.

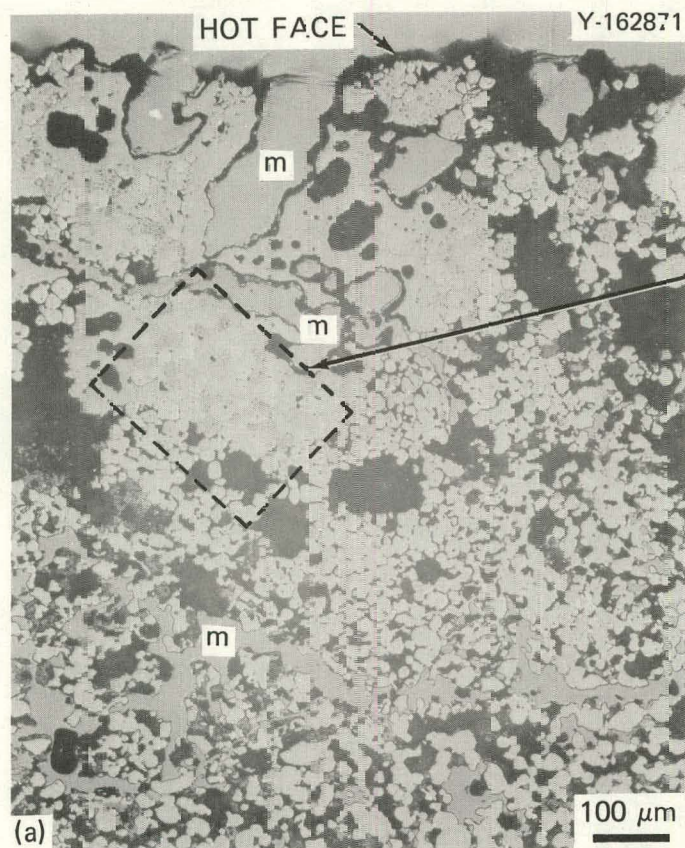
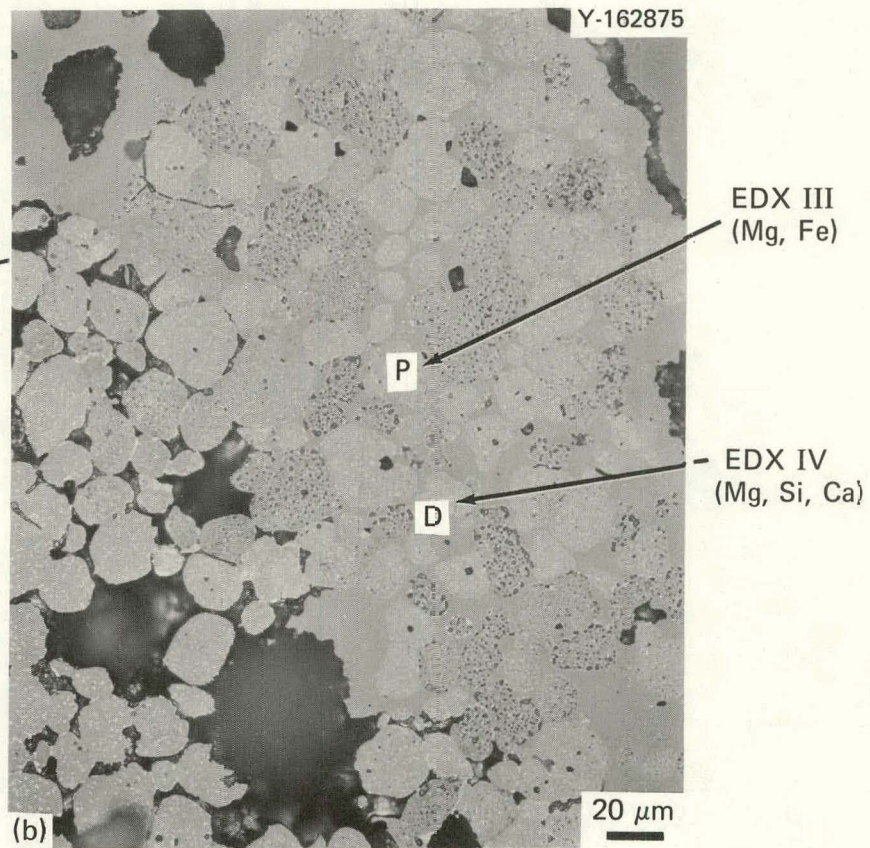
The microstructure at the hot face shown in Fig. 9 was similar in appearance to that at the cold face, except for a region of apparently more densely packed grains. Denser regions, such as that shown in Fig. 9, were found only at isolated sites along the hot-face surface. We suspected that these regions would reveal information about degradation reactions. Energy-dispersive x-ray analysis plots for the areas indicated in Fig. 9 (EDX III and EDX IV) are shown in Figs. 10 and 11. Figure 10 shows that the light-gray area (EDX III) in the region of dense grains in Fig. 9 consisted mainly of magnesium with a small amount of iron; therefore, these areas are periclase, with iron in solid solution. Figure 11 shows that the medium-gray areas (EDX IV) in Fig. 9 contain Mg, Si, and Ca. These areas probably consist

of diopside ($\text{CaO} \cdot \text{MgO} \cdot 2\text{SiO}_2$) and/or monticellite ($\text{CaO} \cdot \text{MgO} \cdot \text{SiO}_2$). Another typical section through the hot-face surface is shown in Fig. 12. The microstructure is similar in appearance to that shown in Fig. 9, and energy-dispersive x-ray analysis of the microconstituents gave similar results.

Fig. 5. Section through the hot face of large brick (sample 6B). dense region. 400X. *P*: periclase MgO ; *D*: diopside, $\text{CaO} \cdot \text{MgO} \cdot 2\text{SiO}_2$.

(a) Showing region of densely packed grains, 100X. (b) Showing mottled grains within the

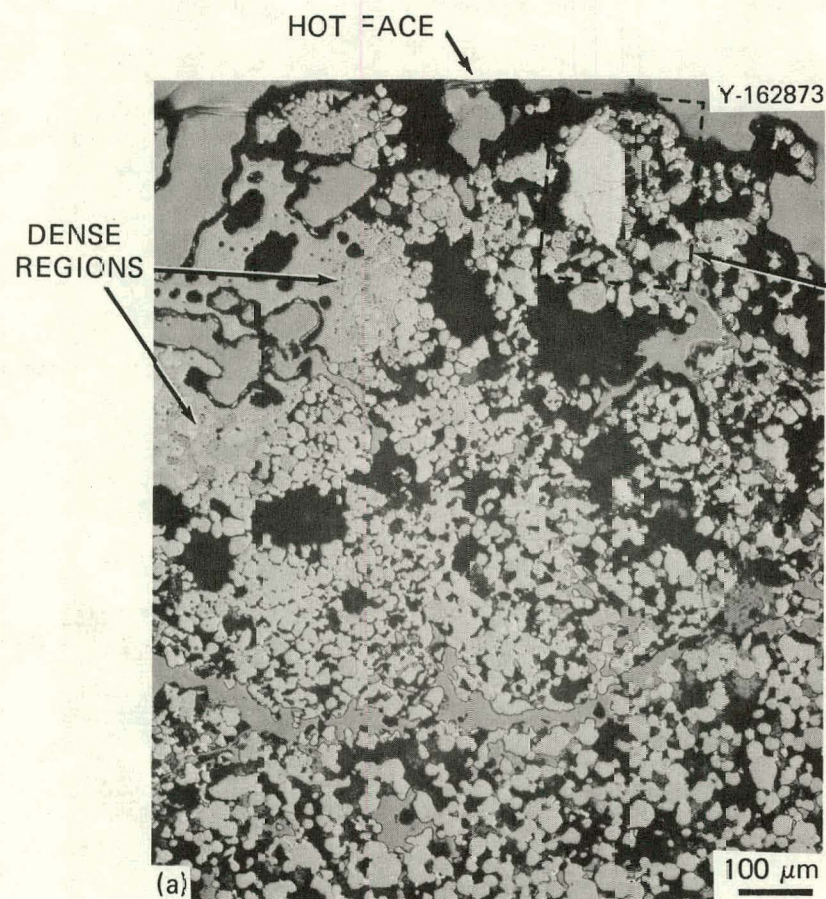
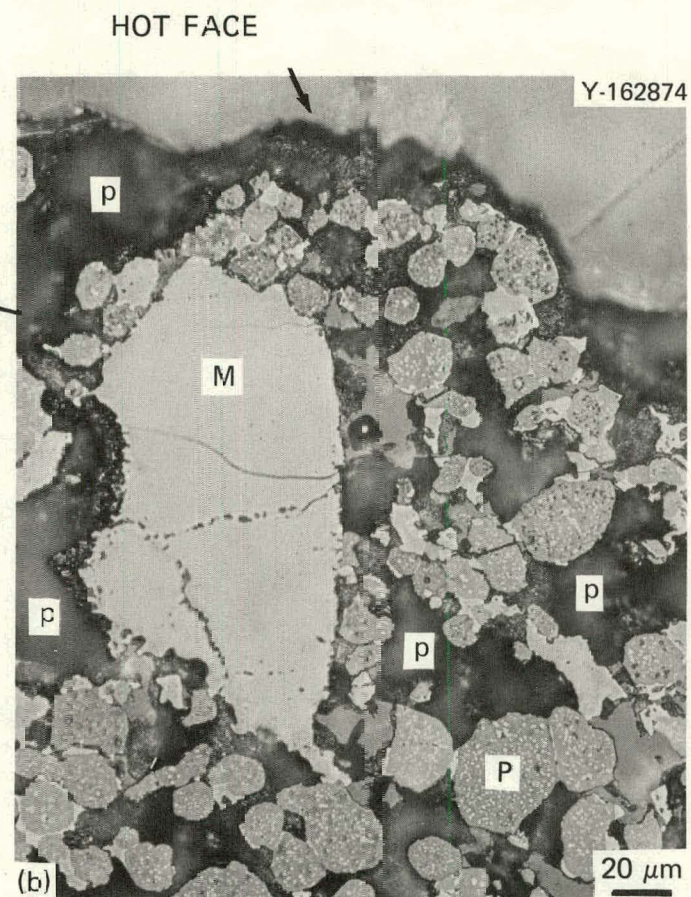
Fig. 12. Microstructure of hot face of large brick (sample 6B). (a) Showing typical area of both loosely joined grains and dense regions, 100X. (b) Showing mottled grains around a large particle, 400X. *M*: magnesiochromite, $(\text{Mg,Fe})(\text{Cr,Al})_2\text{O}_4$; *P*: periclase, MgO ; *p*: porosity.

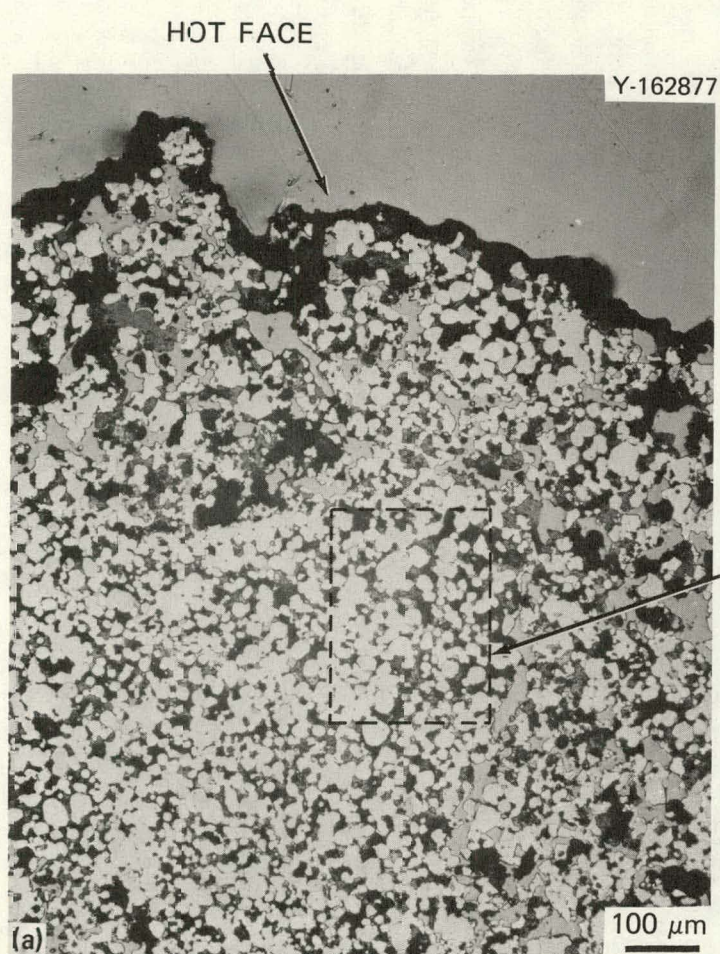
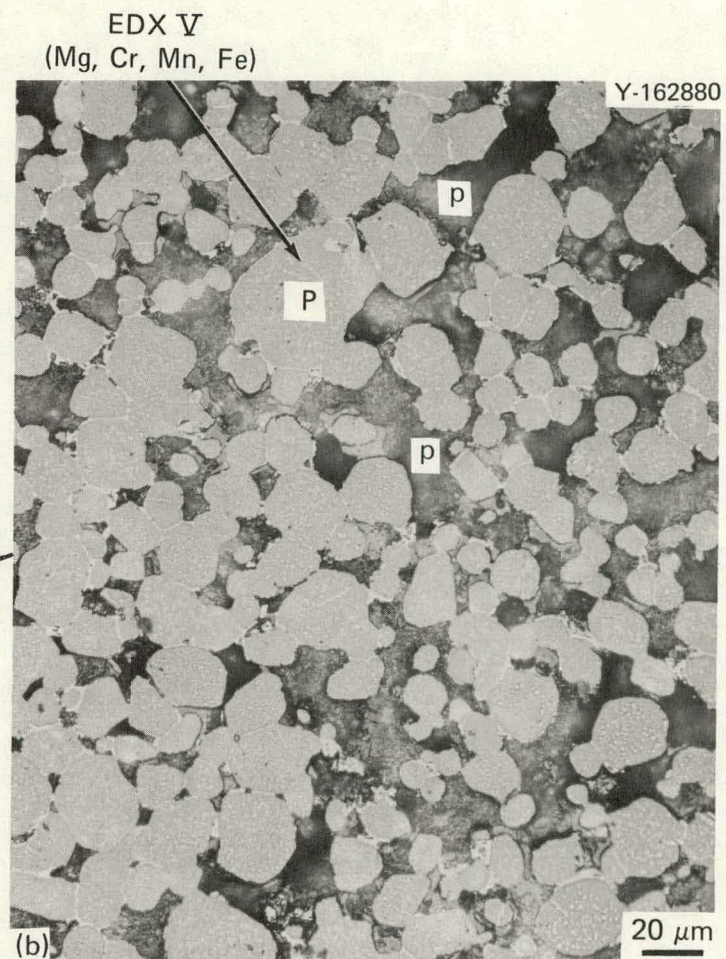
The microstructure of the small brick in a region of the hot face, shown in Fig. 13, is similar in appearance to that of the cold face. An energy-dispersive x-ray analysis of the grains (EDX V) shown in Fig. 14 reveals magnesium as the major element, with smaller amounts of Cr, Mn, and Fe. The principal phases are probably periclase and magnesioferrite. Several dense regions, as shown in Fig. 15, were observed on the hot face. The dense regions in this specimen, however, do not resemble those in the large brick. Whereas those in the large brick consisted of rounded particles in a matrix, the region shown in Fig. 15 consists of angular light-gray particles distributed in a matrix. An energy-dispersive x-ray analysis of the light area (EDX VI) shown in Fig. 16 reveals high concentrations of Mg, Al, Si, Cr, and Fe and barely detectable amounts of K and Ca. These elements could be present in several of the phases listed in Table 4, but we cannot be certain of the composition. The characteristic x-ray spectra for the matrix phase in the dense region (EDX VII) in Fig. 17 shows high concentrations of Mg, Al, and Si, with smaller amounts of K, Ca, Cr, and Fe.

Fig. 13. Microstructure of hot face of small brick (sample 4B). (a) Showing an aggregate of small grains, 100X. (b) Showing loosely joined grains, 400X. *P*: pericase, MgO; *p*: porosity.

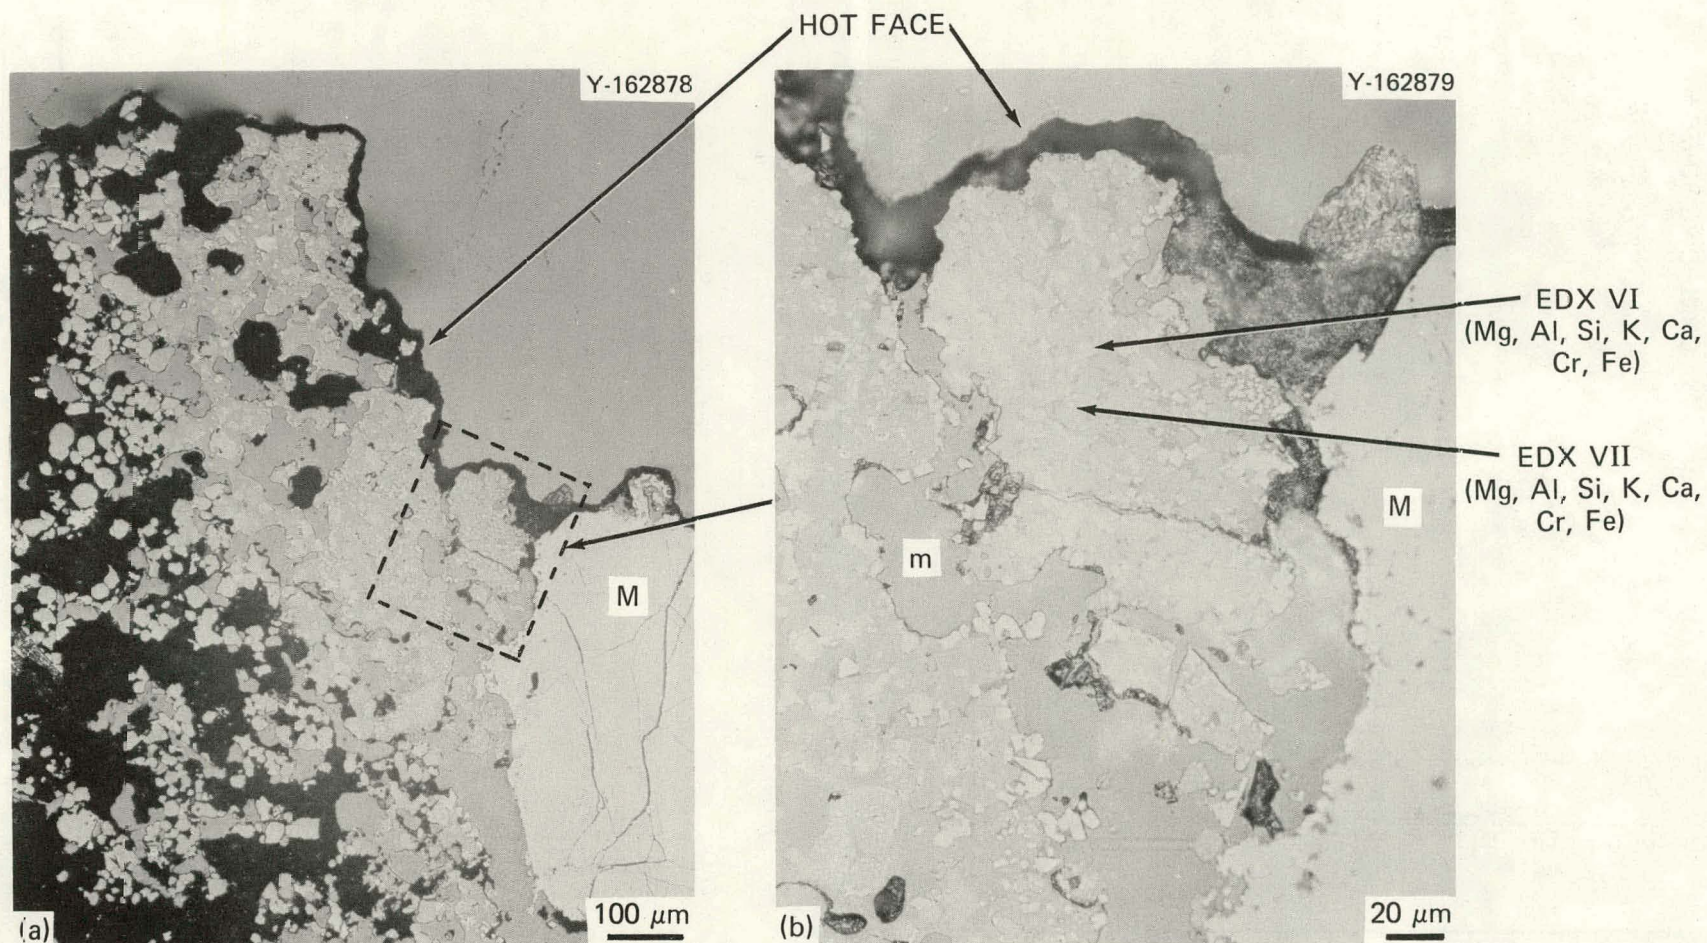
Fig. 15. Microstructure of hot face of small brick (sample 4B). (a) Showing region of dense grains at the surface, 100 \times . (b) Showing the dense region at 400 \times . *M*: magnesiochromite, $(\text{Mg,Fe})(\text{Cr,Al})_2\text{O}_4$; *m*: mounting material.

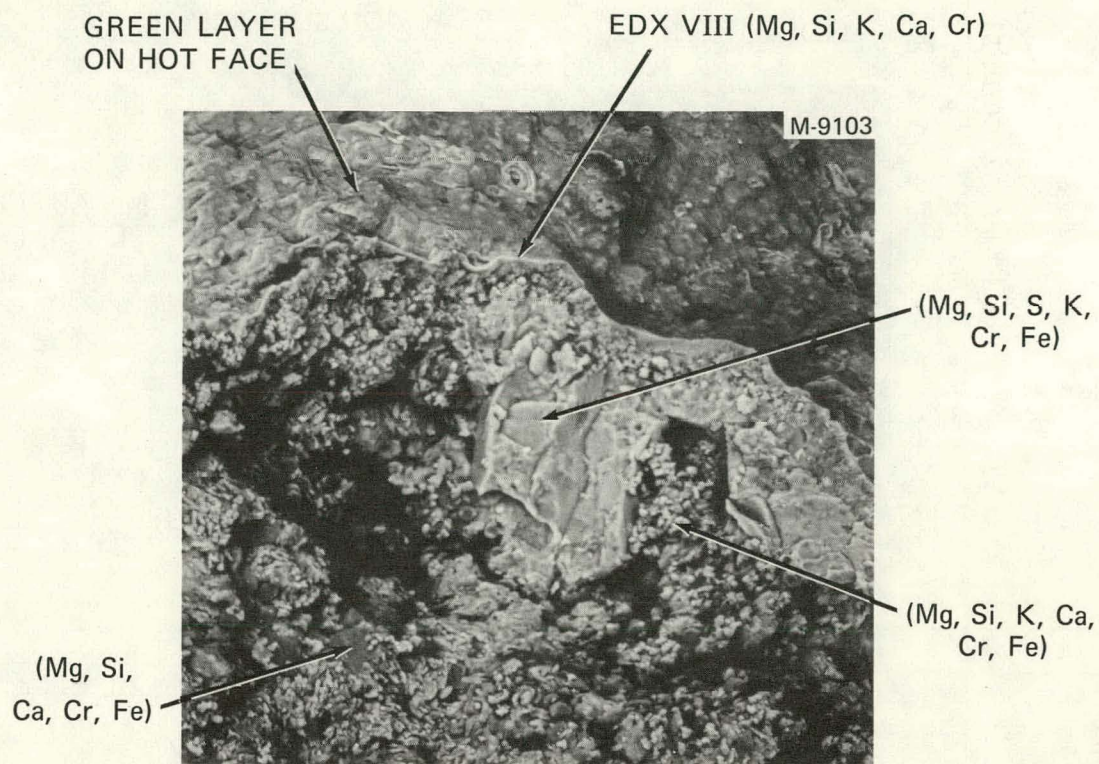
in Fig. 18. The previously mentioned green layer is visible as a thin dense region. An energy-dispersive x-ray analysis of the green layer (EDX VIII) in Fig. 19 detected high concentrations of potassium and calcium. Magnesium, silicon, and chromium were also present, but aluminum and iron were absent. Several other regions near the hot face contained high concentrations of Ca, K, and Mg. We found no fuel impurities which were not already major elements in the original brick. (Gold was coated on the specimen for analysis purposes and was neither an impurity in the brick or in the fuel oil.)

Fig. 18. Scanning electron microscope picture of fracture section through hot face of small brick.

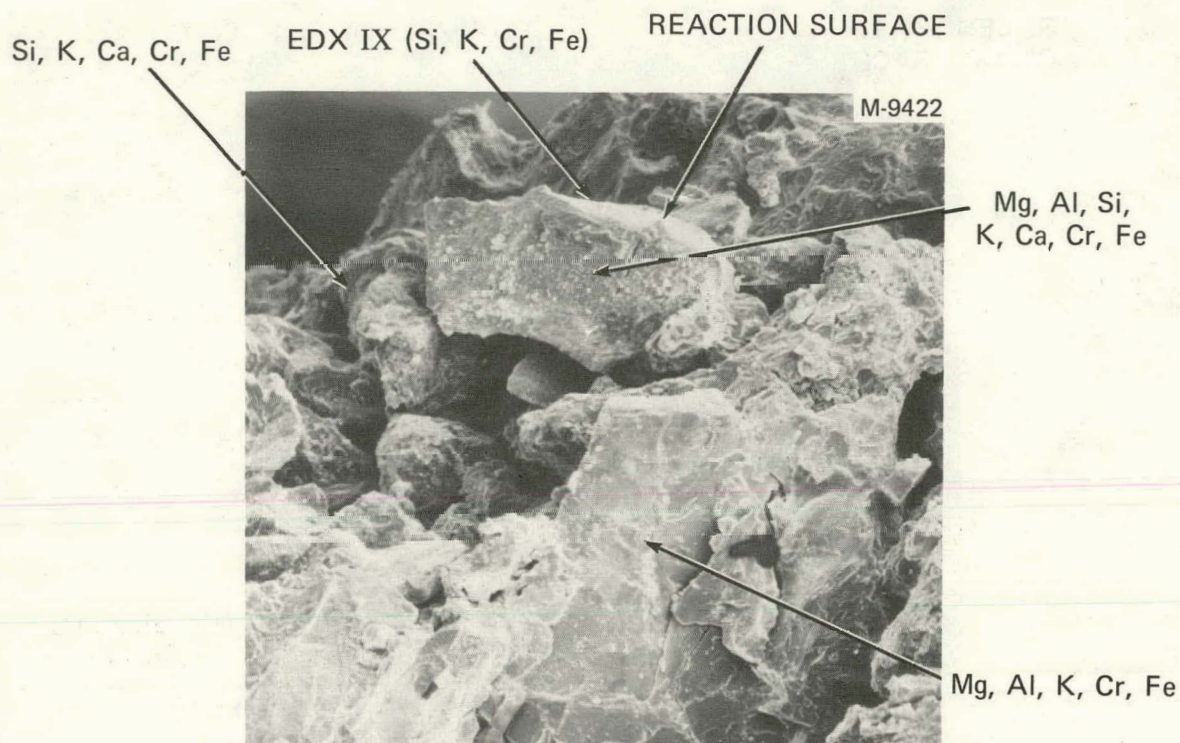
Figure 20 shows a fracture section through the hot face of the large-brick specimen. An energy-dispersive x-ray analysis of the reaction layer in Fig. 21 detected Si, K, Cr, and Fe. Other regions had high concentrations of Mg, Al, Si, K, Ca, Cr, and Fe, but no fuel impurities such as Na, Ni, P, S, and V. We conclude that neither the reaction layer nor the near-surface region contains impurities directly traceable to the fuel oil. The high concentrations of potassium frequently observed were probably derived from the materials being heated in the kiln.

Fig. 20. Scanning electron microscope picture of fracture section through hot face of large brick.
